**NEVERSINK RESERVOIR DAM
SULLIVAN COUNTY NEW YORK
INVENTORY NO 348**

**PHASE I INSPECTION REPORT
NATIONAL DAM SAFETY PROGRAM**

NEW YORK DISTRICT CORPS OF ENGINEERS

AUGUST 1978

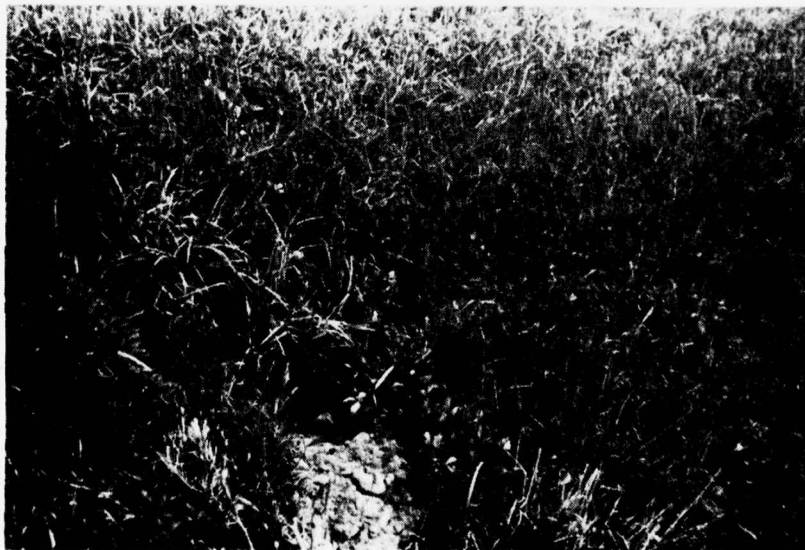
6. Typical woodchuck hole in downstream embankment (estimate 100 holes in embankment).

The dam embankment shows no sign of movement, seepage or distress and is generally in good condition. The visual inspection located a significant number of animal holes, believed to be woodchuck holes, in the downstream embankment. The holes have caused minor sloughing and erosion and present a nuisance to individuals who have to mow and maintain the dam embankment. The New York Department of Environmental Conservation Fish and Game Section indicate woodchucks will burrow very close to the surface (See Appendix E) and should not be capable of causing piping in a large dam. The downstream face of the dam is being implanted with crown vetch in an effort to minimize mowing and maintenance work. This will make it difficult to visually inspect the embankment surface and is not beneficial to overall dam safety considerations. It is important to notice problems at the embankment at an early stage. While frequent mowing of the embankment can be a significant expense, it allows the dam owner the opportunity to routinely visually inspect the embankment surface.

- 2) Minor erosion and sloughing problems from animal holes should be attended to.
- 3) Deteriorated concrete surfaces in the spillway area should be repaired.
- 4) The exposed shale along the face of western upstream abutment of the reservoir should be protected from erosion.

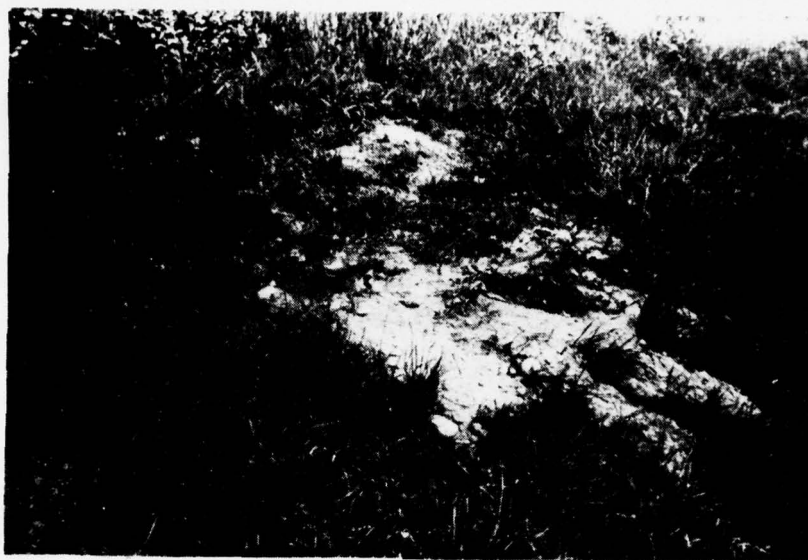
7. Another woodchuck hole showing extent of earth that can be removed. Minor sloughing also occurs.

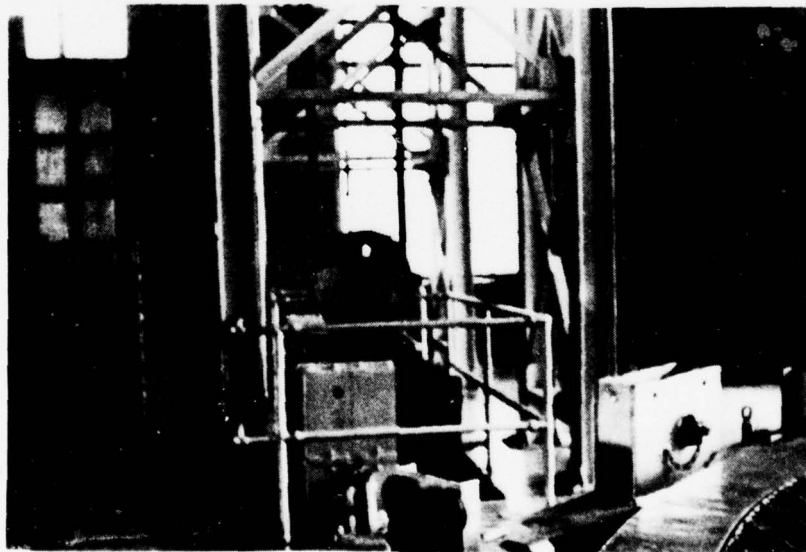
8. Gate house area showing control gate mechanism. Full time staff keeps facility well maintained.

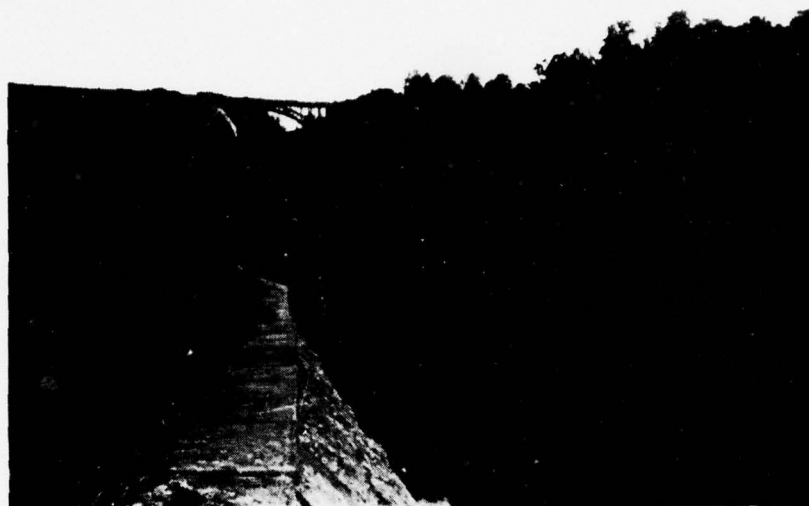
9. View of emergency spillway from stilling basin area. Notice significant vegetative growth in spillway. Left is fence. Discharge tunnel is submerged in basin.

VISUAL EXAMINATION OF	OBSERVATIONS	REMARKS OR RECOMMENDATIONS
CONCRETE WEIR	Some surface spalling. Very minor leaking through joints in the masonry.	
APPROACH CHANNEL	Reservoir face.	
DISCHARGE CHANNEL	Some vegetative growth which should be removed from emergency spillway channel	
BRIDGE AND PIERS	Good.

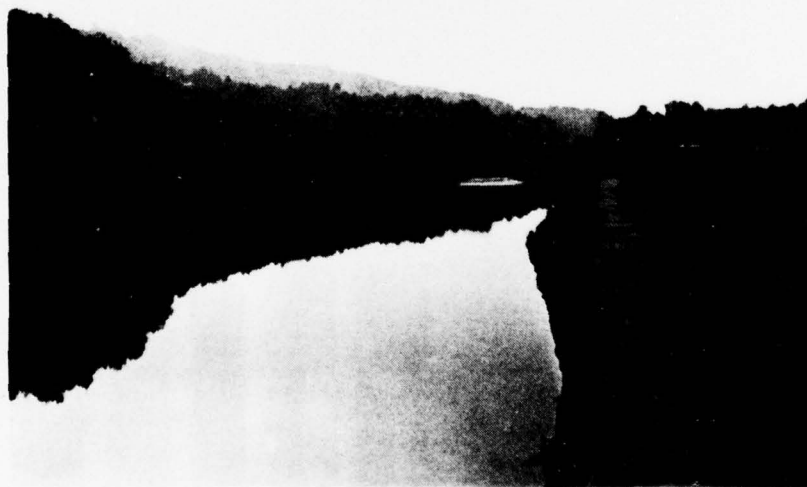
10. View of downstream area below stilling basin.

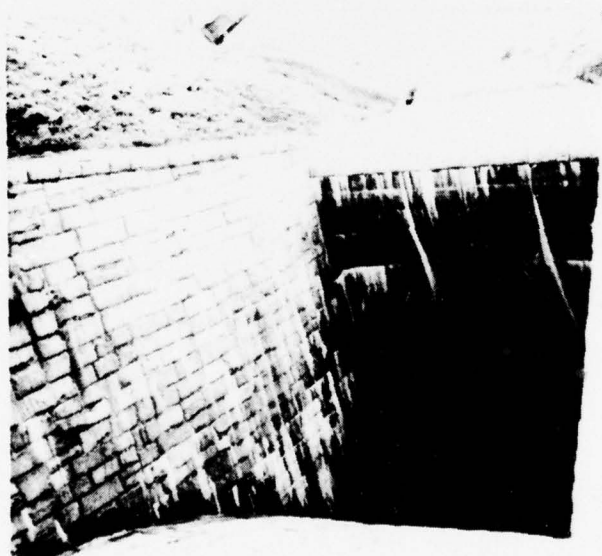
12. View of entrance to discharge tunnel.
Some spalling has occurred.

VISUAL EXAMINATION OF	OBSERVATIONS	REMARKS OR RECOMMENDATIONS
CRACKING AND SPALLING OF CONCRETE SURFACES IN OUTLET CONDUIT	Surface spalling of approximately 1" on 20% of invert concrete panels. Two small areas have exposed the welded wire fabric reinforcement.	
INTAKE STRUCTURE		
OUTLET STRUCTURE		
OUTLET CHANNEL	Good.	
EMERGENCY GATE

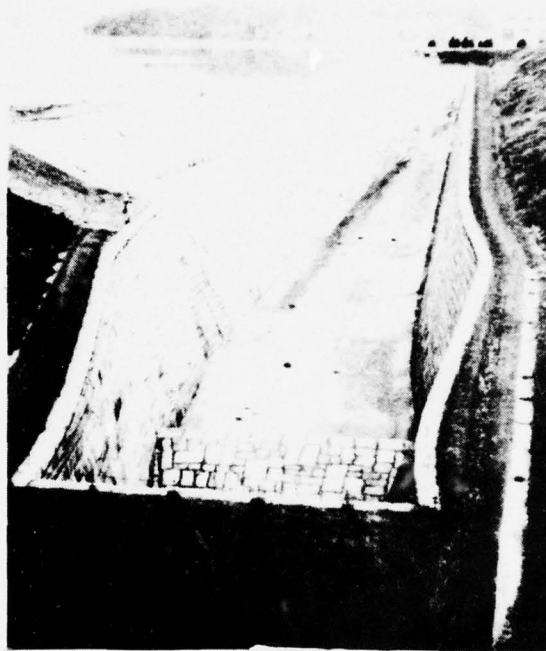
13. Spillway side channel. Significant spalling has occurred in this area.

The spillway is a masonry ogee type structure which falls in three tiers into a large side channel spillway trough. Significant spalling of the concrete floor system with some undermining of the spillway facing has occurred and minor seepage was evident at the time of inspection. The masonry work generally remains in good

The stone masonry spillway (waste weir) is generally in structurally good condition, but limited seepage occurs through the spillway masonry. The floor of the spillway chute (weir channel) consists of poured concrete. Deterioration (spalling and cracking) of this concrete has occurred at several locations. Masonry for the waste channel downstream of the spillway weir channel generally is in good condition.
